Action Memorandum No. 24-052: Authorizing the City Manager to Issue a Contract to Perform Additional Interior Demolition at The Palmer Public Library to Determine the Full Scope of Structural Damagewith Steppers Construction Inc. for an Amount Not to Exceed \$44,844

Palmer Public Library Damage Survey and Assessment

Subject: Palmer Library Damage Architectural Assessment

Structural Analysis Report

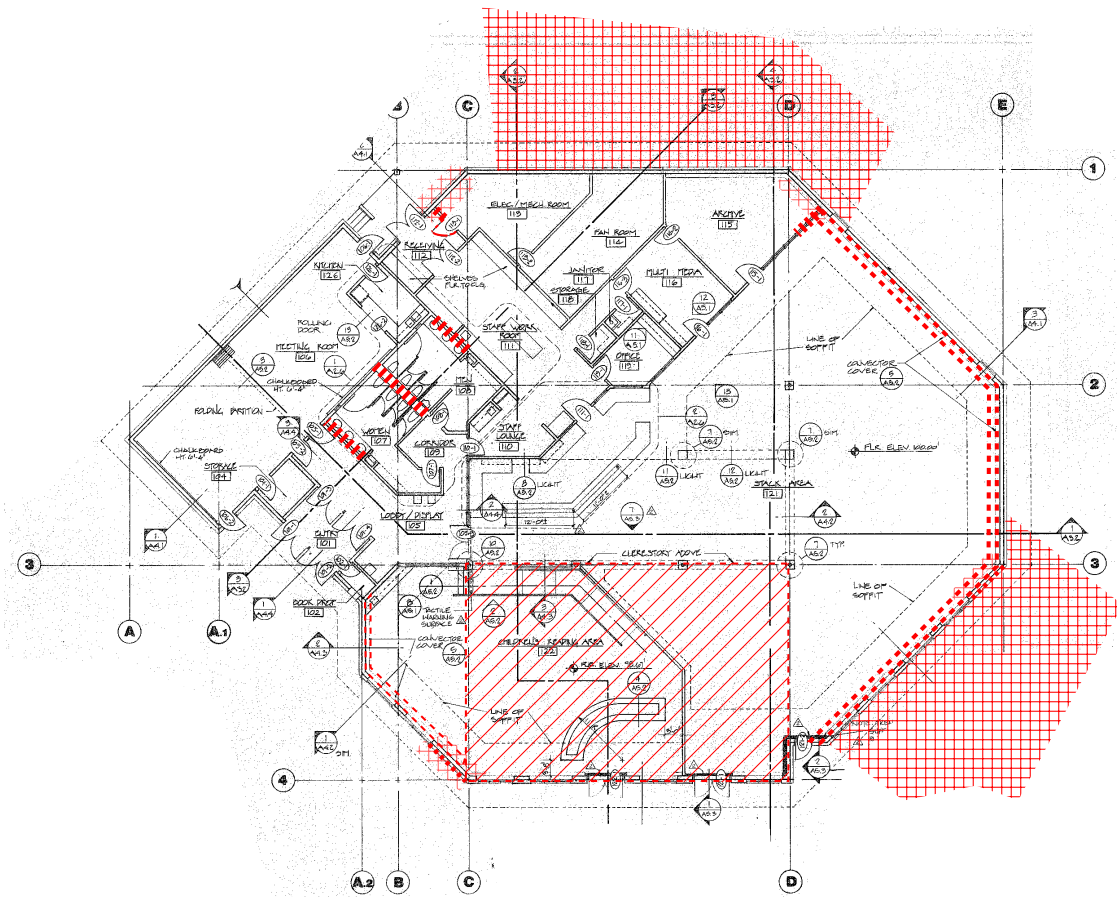
Palmer Public Library
Existing Conditions Damage Assessment
Structural Exterior and Interior Wall Demolition/Repair

EXISTING BERMING TO BE REMOVED /REPLACED TO FACILITATE STRUCTURAL REPAIR
-

REMOVE AND REPLACE STANDING SEAM ROOFING
-

AREA OF COLLAPSE TO BE REPLACED
-

INTERIOR/EXTERIOR WALL CONSTRUCTION REQUIRE TO REPAIR STRUCTURAL/PLUMBING DAMAGE

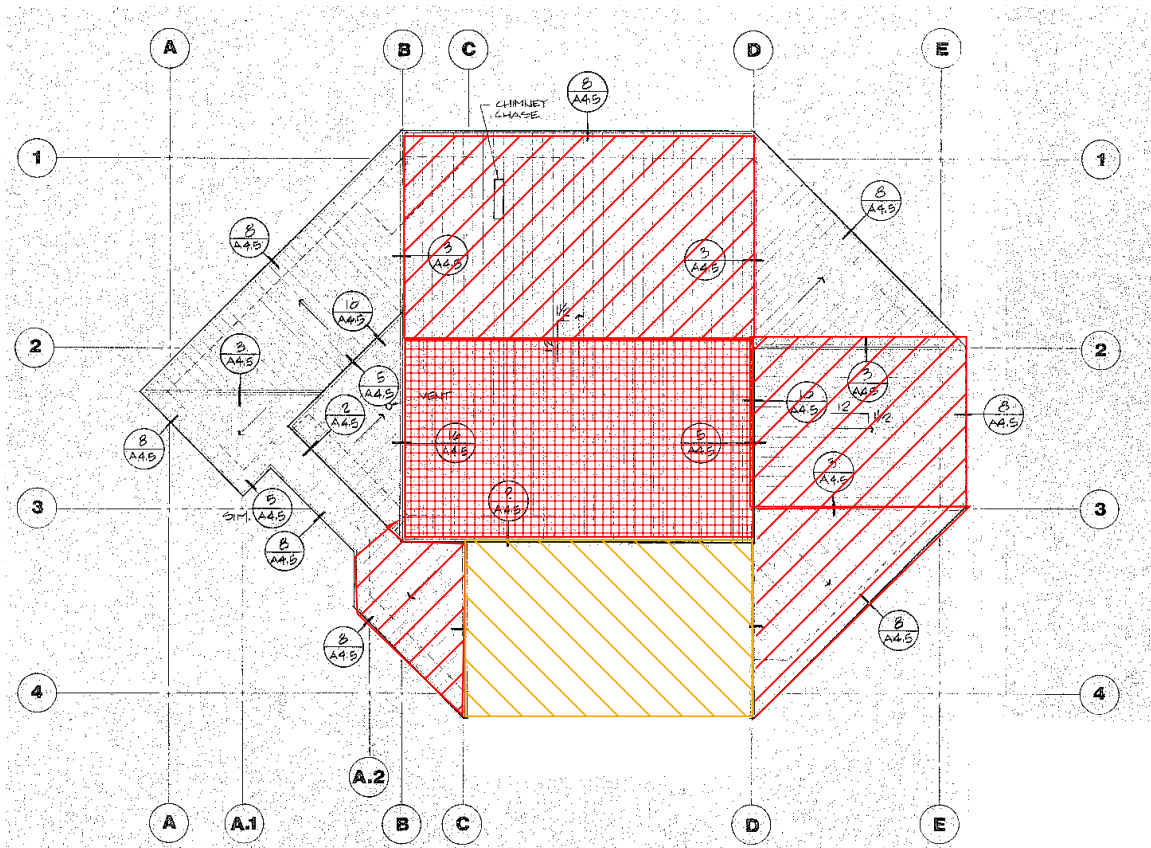
Palmer Public Library
Existing Conditions Damage Assessment
Roof Structural Demolition/Repair

1) REPAIR STRUCTURE, 2) REMOVE AND REPLACE SHEATHING, 3) REPLACE ROOFING
-

REMOVE AND REPLACE STANDING SEAM ROOFING
-

AREA OF COLLAPSE TO BE REPLACED

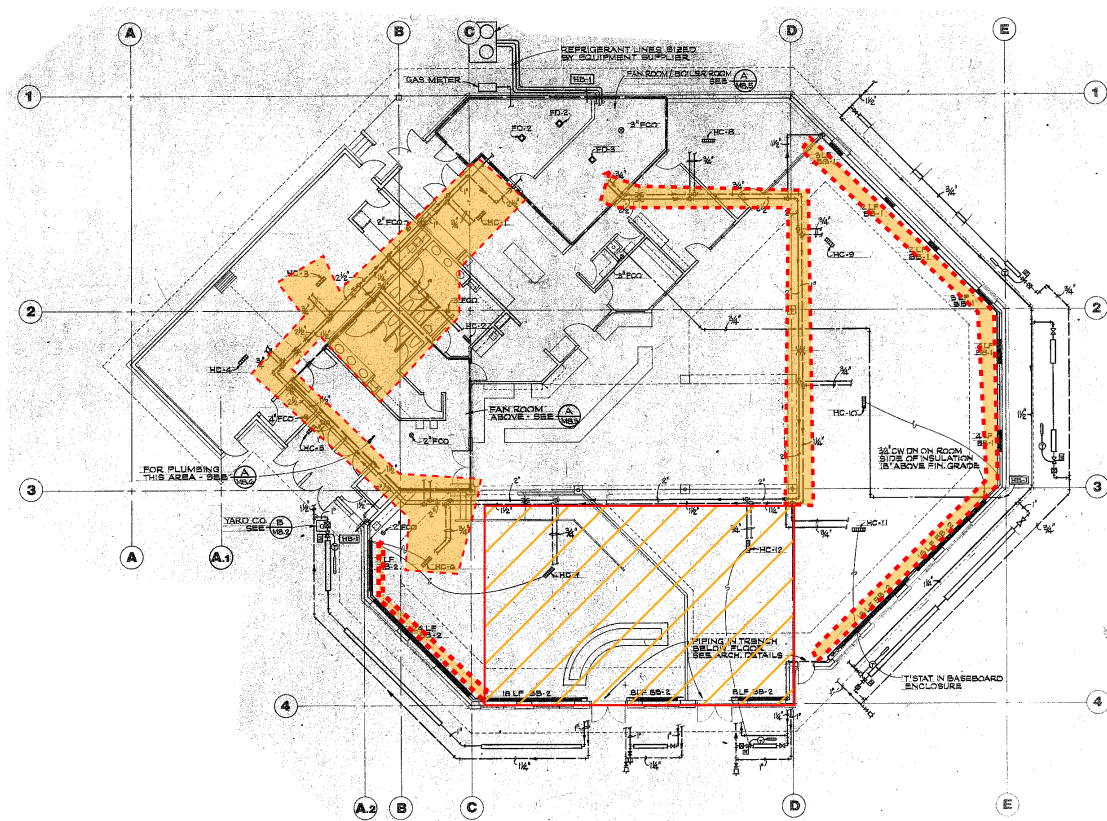
Palmer Public Library
Existing Conditions Damage Assessment
Hydronic System Plan - Demolition/Repair

DAMAGED WATER PIPING TO BE REMOVED AND REPLACED

AREA OF COLLAPSE TO BE REPLACED

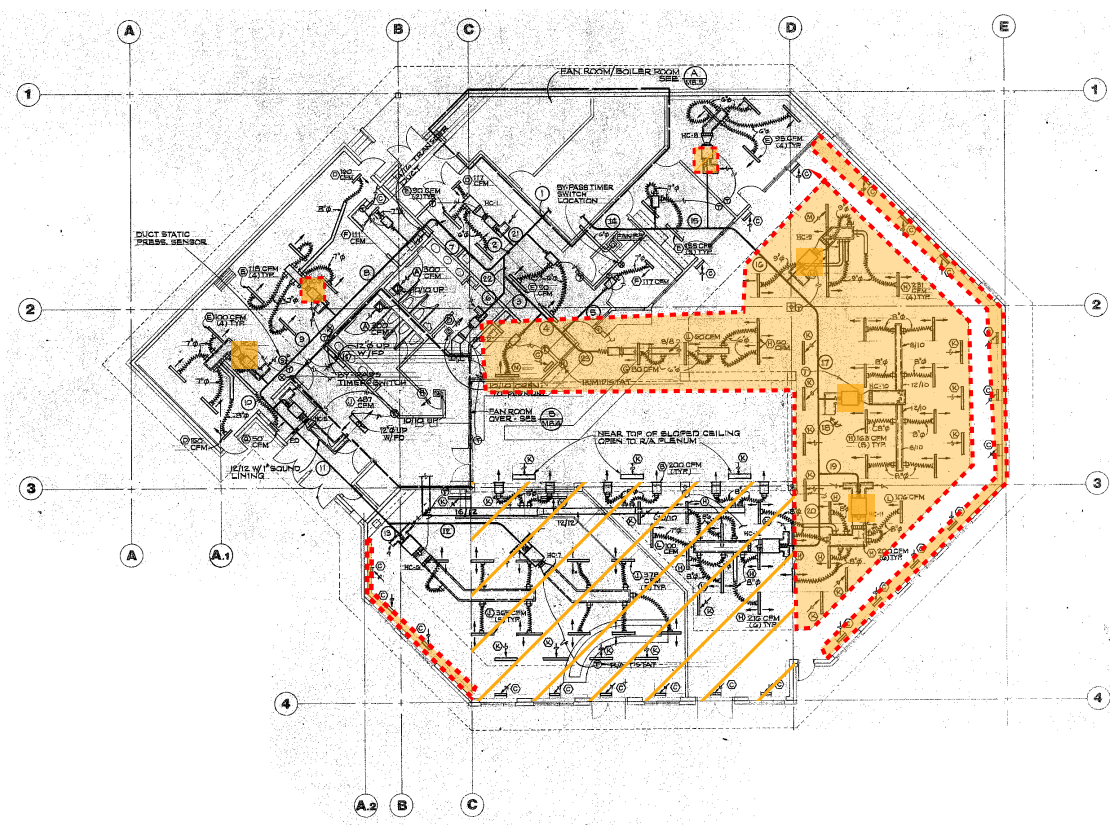
Palmer Public Library
Existing Conditions Damage Assessment
HVAC System Ceiling - Demolition/Repair

DAMAGED WATER PIPING / VAV BOXES TO BE REMOVED AND REPLACED

AREA OF COLLAPSE TO BE REPLACED

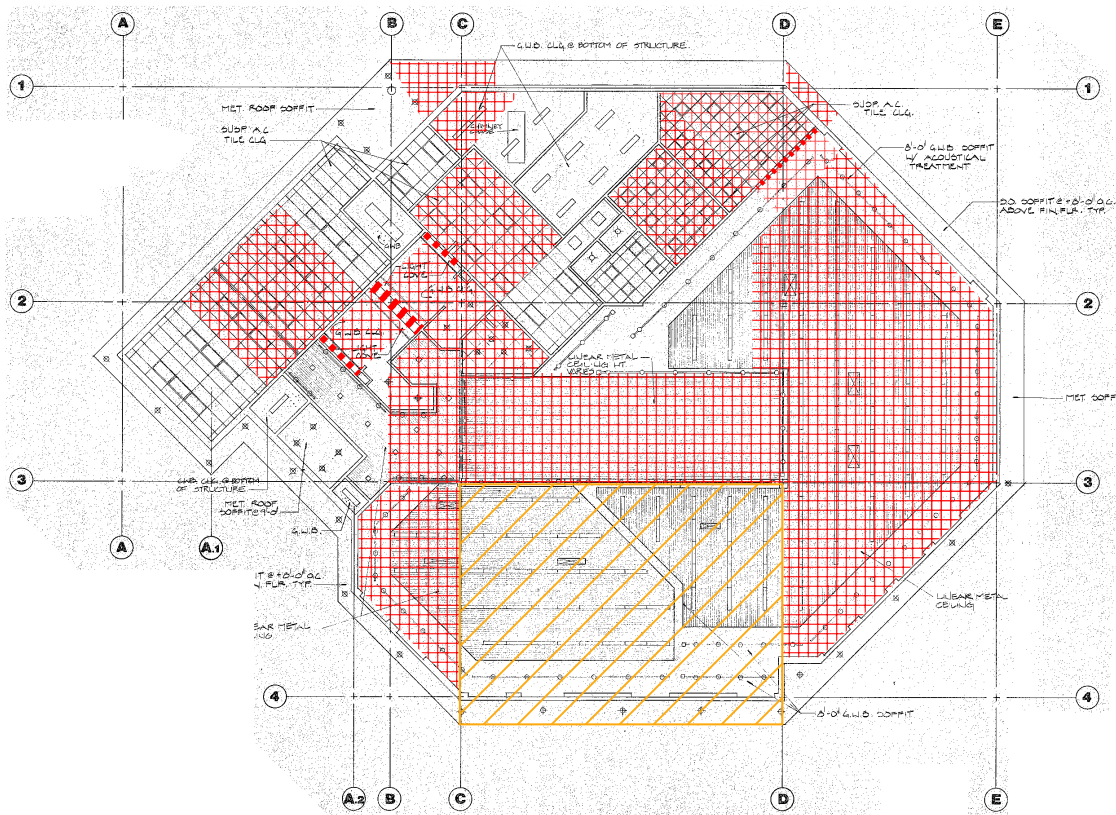
Palmer Public Library
Existing Conditions Damage Assessment
Overall Ceiling - Demolition/Repair

EXISTING CEILING OR SOFFITING TO BE REMOVED AND REPLACED
-

AREA OF COLLAPSE TO BE REPLACED

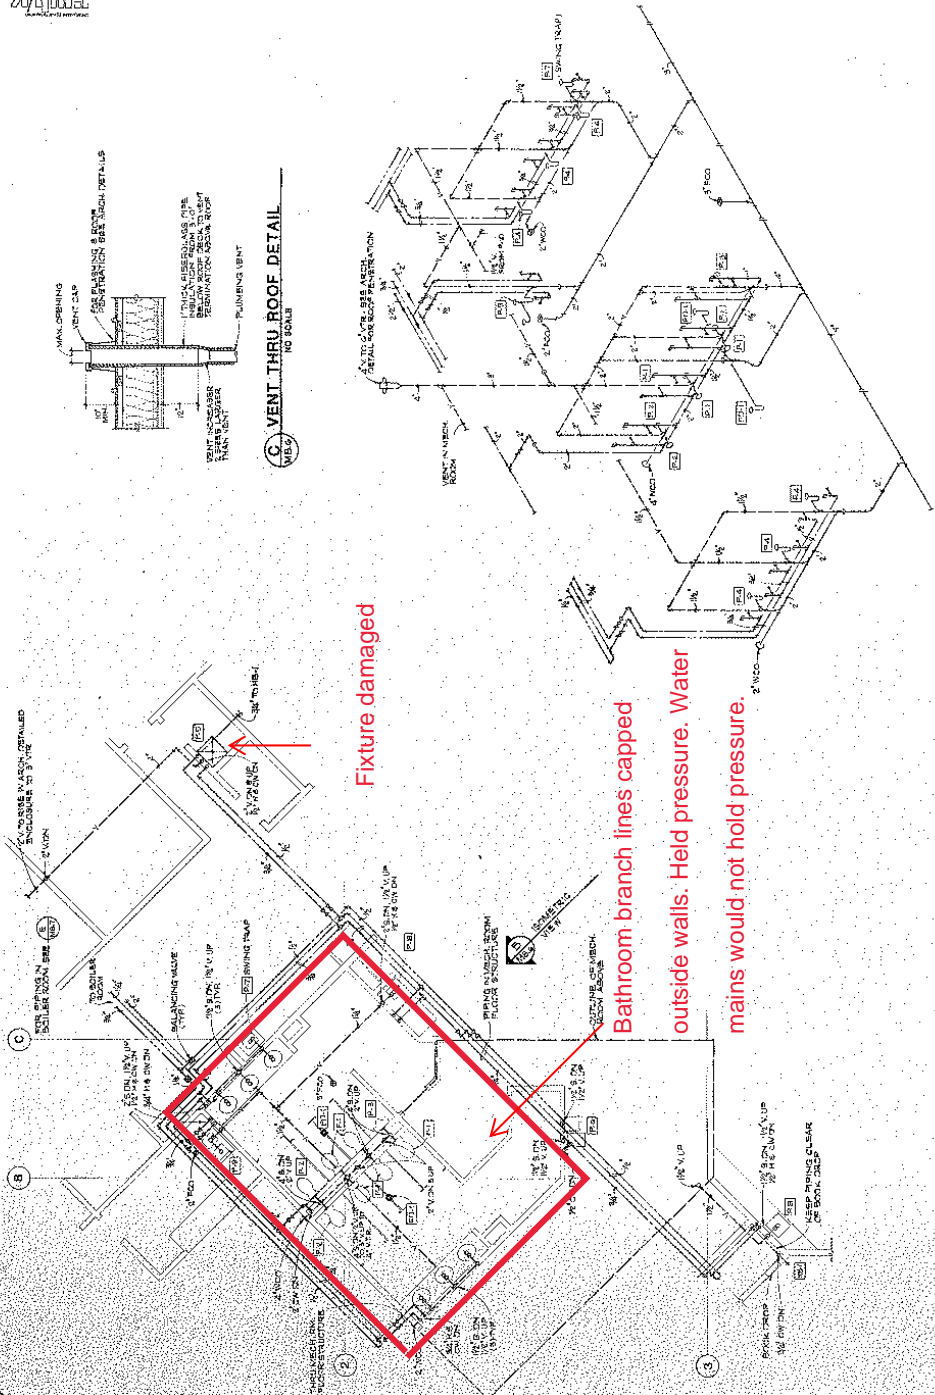
Fixture damaged

Bathroom branch lines capped
 outside walls. Held pressure. Water
 mains would not hold pressure.

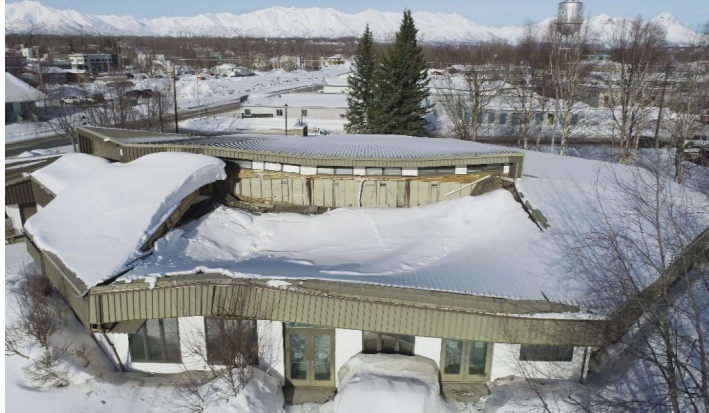
Image 1: Palmer Library Roof Collapse

The roof of the Palmer Public Library suffered a partial collapse on February 15, 2023. The collapse occurred mainly over the children’s section of the library. However, surrounding areas were also impacted by the roof collapse. The City of Palmer engaged PND Engineers, Inc. (PND) to analyze the existing structure. PND used the International Existing Building Code (IEBC) to determine the

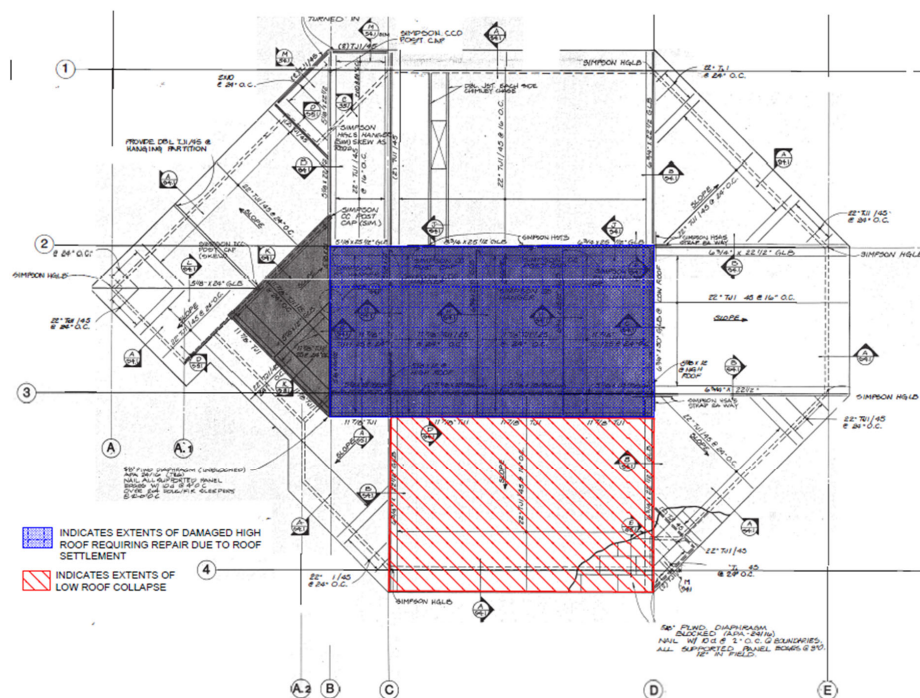
The Palmer library currently meets all three of these requirements. The beam line failure that led to the collapse supported more than 30% of the building's loads, including snow loads. Additionally, the area between the low and high roof where the collapse occurred is part of the lateral system as it is a transfer area carrying lateral loads from the high roof diaphragm to the low roof diaphragm. Therefore, this structure is considered, by code, to have sustained substantial structural damage. See Figure 1 for a diagram of the extents of the building damage. This figure only identifies the areas of known damage. Additional damage may be discovered as building finishes are removed.

Figure 1: Existing building roof plan with a summary of the damage observed during PND's site visit.

Therefore, due to the extent of the damage and cause of the damage, all members of the structure that were damaged during the roof collapse and the members supporting them must be replaced with members capable of withstanding the current code required gravity loads. Furthermore, due to the significant damage of the vertical elements of the high to low roof shear wall that provides diaphragm shear load transfer, the entire building must be seismically retrofitted to resist 75% of the current code required loads if the pre-damage state of the structure cannot resist that level of load.

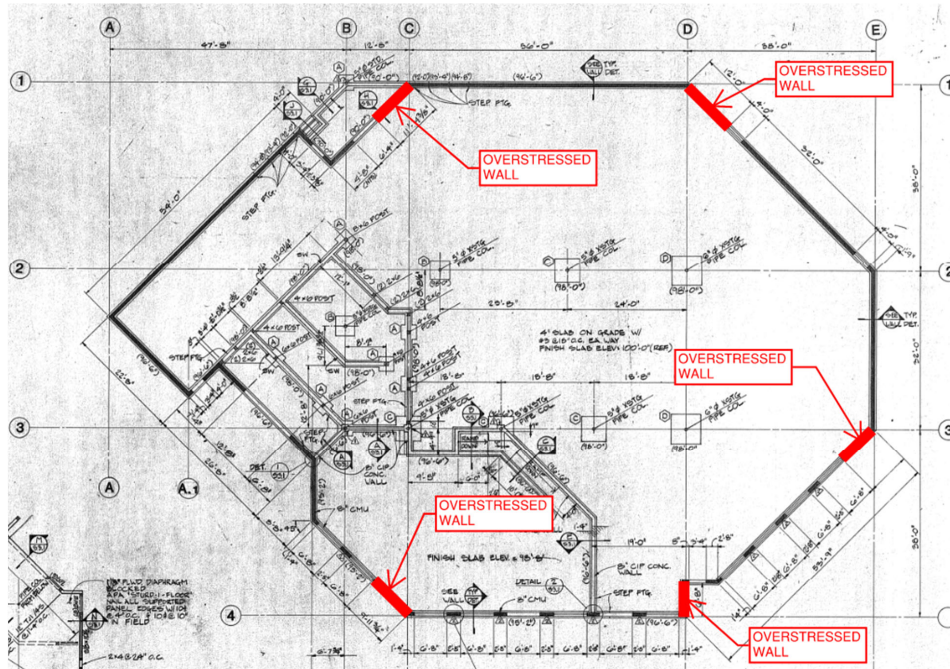
The masonry walls were analyzed for the forces that were determined using the RAM model of the structure. It was determined that there are 5 walls that are overstressed under the current required design loads. Four of the five walls were overstressed by 120% with the worst case wall at 162% over capacity. The deficient walls are highlighted

in red in the diagram below. These walls must be retrofitted to be brought into compliance. The exterior and interior finishes would need to be removed to expose the walls. A product like Fiber Reinforced Polymer (FRP) could be installed to add additional strength to the walls. Fiber reinforced polymer is composed of strong fibers that are arranged in a matrix that are applied to the surface of existing concrete or masonry walls to add strength to the wall. Image 1 shows an example of FRP applied to a concrete wall using a system by Simpson Strong-Tie.

Figure 2: Diagram indicating overstressed walls in red

removal of finishes and application of a strengthening system such as FRP. Alternatively, openings may be filled in to allow for longer portions of full height shear walls to remove load from the overstressed walls.

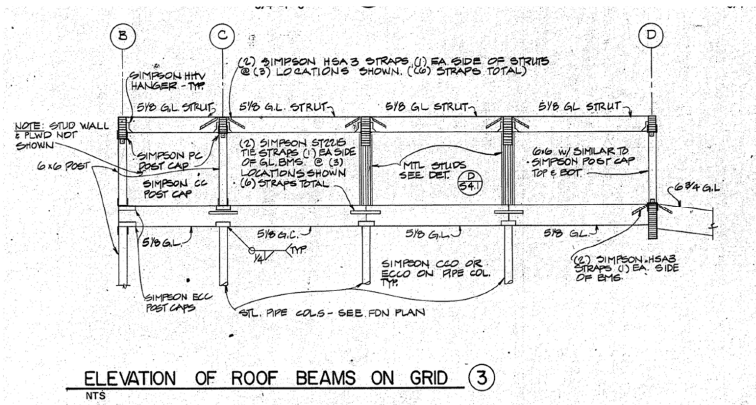
There is a vertical irregularity in the diaphragm along grid 3, where the diaphragm is split to form a low and high roof. This is defined as a type 3 diaphragm discontinuity irregularity in ASCE 7. The diaphragm is the primary element that takes the loads induced in a seismic or wind event and transfers them to the shear walls. The loads accumulate across the building and then must be transferred from the high roof to the low roof. This is referred to as a transfer area. These types of irregularities are often improperly detailed in high seismic areas. In the past it was common to design the diaphragms as two, three sided diaphragms, this assumes that they will act independently from each other. Improvements in the code and design techniques for this type of irregularity have occurred in recent years. It is now understood that it is imperative that the transfer area be designed and detailed to properly tie the two regions together. If the two regions are not tied together properly then there is a high likelihood that during a high lateral load event the two diaphragms will deflect differently putting large stresses on the members, and leading to roof collapses, not unlike the one that has occurred.

The irregularity at the library consists of three bays of windows framed by glu-laminated strut beams, supported on metal studs. See Figure 3 for the elevation at the vertical irregularity. Between grid B and grid C there is a double-sided shear wall that is intended to transfer the shear loads to the diaphragm below. The wall is capable of transferring the required load, however, the glu-laminated struts are not. Per the elevation below, there is a strap on either side of each GLB, this strap has a capacity of approximately 1,900 pounds. Likewise, at the low roof level the load must be transferred out of the shear wall and back into the diaphragm so it can be transferred to the masonry shear walls. The straps used on the beams below provide only 1,875 pounds of resistance. Additionally, due to the likelihood of failure at one of these points the code now requires the elements of this nature be designed for an increased load of 125%. Therefore, a retrofit of the drag struts would need to be designed for approximately 15,000 pounds. The capacity of the straps needs to be increased from the current capacity of a maximum of 1900 pounds to the code required 15,000 pounds.

Figure 3: Elevation of vertical irregularity at grid 3

Major upgrades need to be completed on the transfer area between the low and high roof. The beams will need to be replaced and sized for the combined gravity and axial loads. Straps need to be provided that are capable of providing adequate resistance on both the high and low roof beams so that the load may be transferred to the shear wall. Additionally, strapping needs to be added to all beams that are part of the collector system in the building. This will require the removal of drywall, ceiling, and other finishes throughout most of the building to gain access to the roof framing members. Lastly, the 5 masonry shear walls that are overstressed will need to be brought up to current code standards. This will require the
