Action Memorandum No. 24-052: Authorizing the City Manager to Issue a Contract to Perform Additional Interior Demolition at The Palmer Public Library to Determine the Full Scope of Structural Damagewith Steppers Construction Inc. for an Amount Not to Exceed \$44,844

Palmer Public Library Damage Survey and Assessment

Subject: Palmer Library Damage Architectural Assessment

Structural Analysis Report

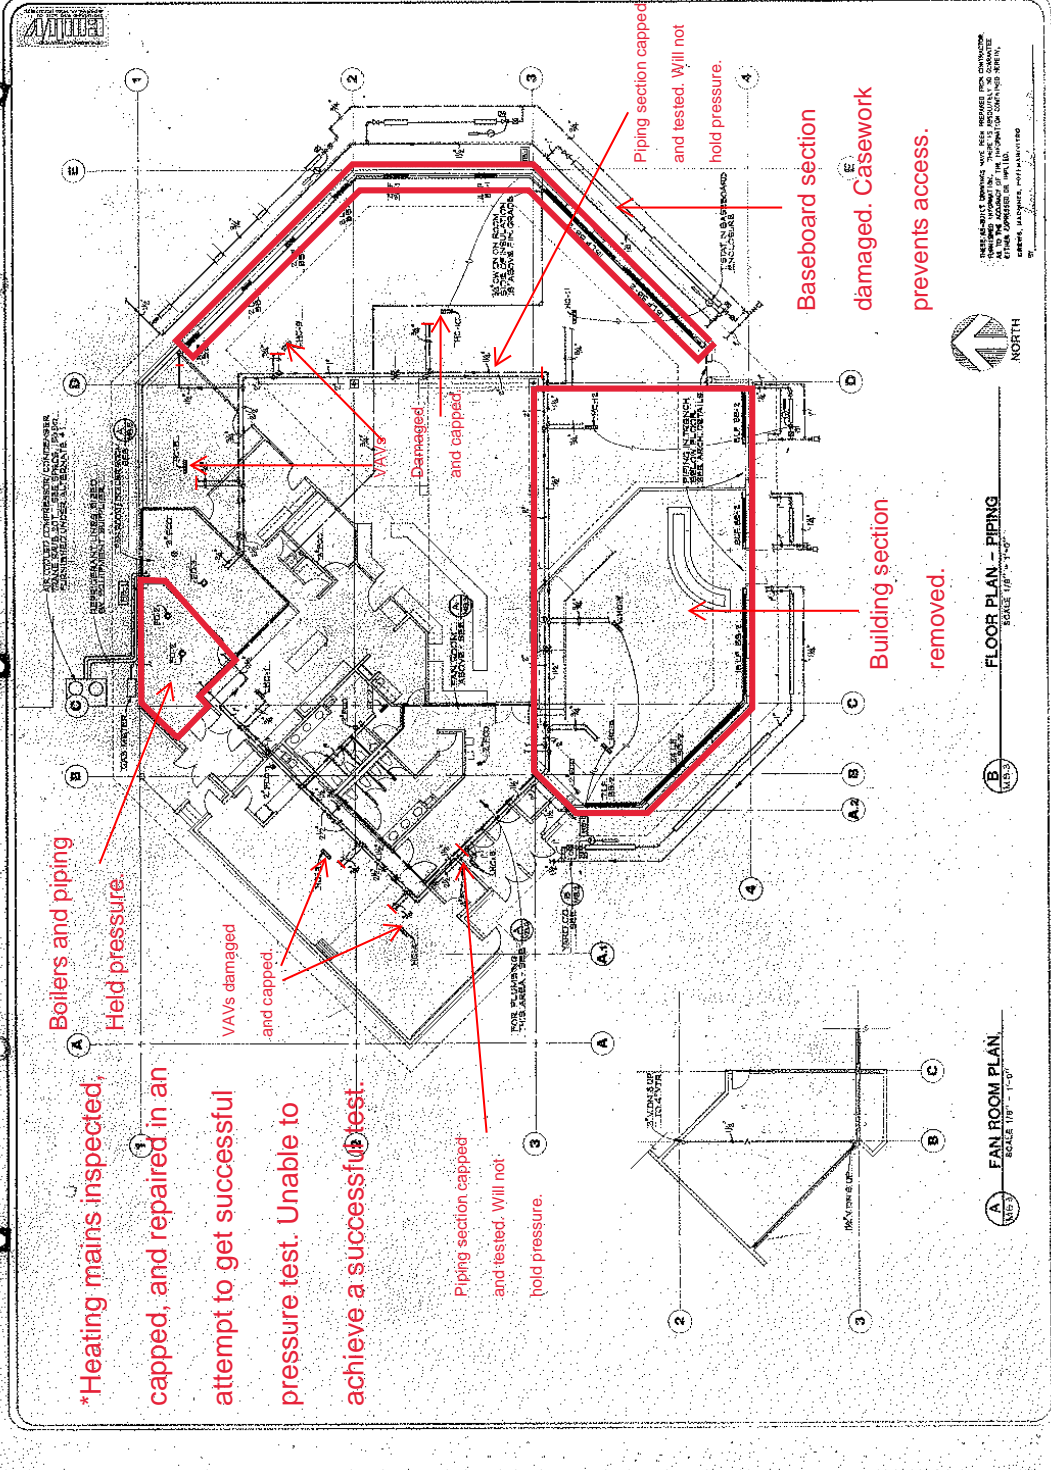
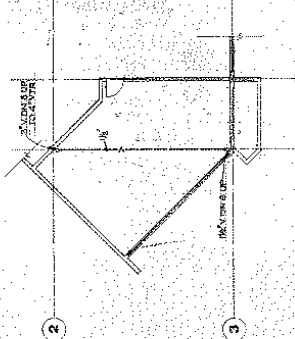
Palmer Public Library
Existing Conditions Damage Assessment
Overall Ceiling - Demolition/Repair

Fixture damaged

Bathroom branch lines capped
 outside walls. Held pressure. Water
 mains would not hold pressure.

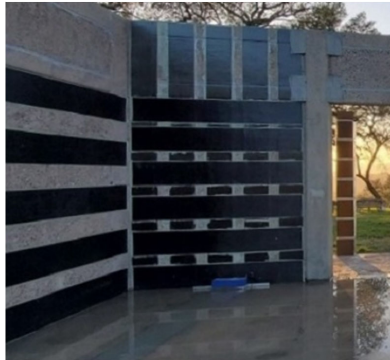
Image 1: FRP Reinforced wall by Simpson

Under the current code the walls would be required to be special reinforced masonry shear walls. An analysis showed that the walls are compliant with all the required aspects of special reinforced shear walls except for one. This item is the requirement that the horizontal bars be hooked around the vertical bars at the wall ends in shear walls. Code section 405.2.3.3 does not require that the walls be updated to meet the current design standard of special reinforced shear walls if they have the capacity to resist the 75% of current code forces.

in red in the diagram below. These walls must be retrofitted to be brought into compliance. The exterior and interior finishes would need to be removed to expose the walls. A product like Fiber Reinforced Polymer (FRP) could be installed to add additional strength to the walls. Fiber reinforced polymer is composed of strong fibers that are arranged in a matrix that are applied to the surface of existing concrete or masonry walls to add strength to the wall. Image 1 shows an example of FRP applied to a concrete wall using a system by Simpson Strong-Tie.

removal of finishes and application of a strengthening system such as FRP. Alternatively, openings may be filled in to allow for longer portions of full height shear walls to remove load from the overstressed walls.

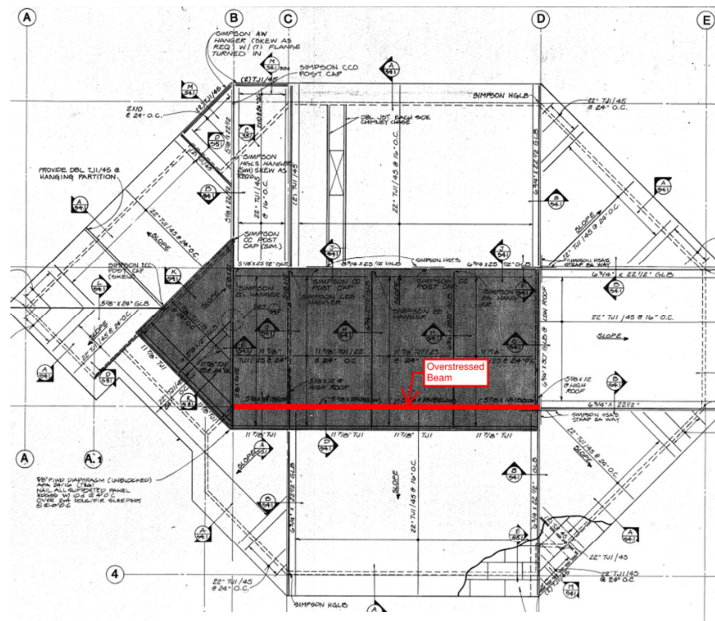
Image 4: FRP Reinforced wall by Simpson

The record drawings specify that the roof was designed for a uniform roof snow load of 40 pounds per square foot (psf). It is possible that the original library designers may have considered additional snow loading to account for potential snow drifts. Snow drift loads are applied to the structure in addition to the uniform roof snow load in to account for the extra weight present on the roof in areas where snow drifts are likely to accumulate. There are no notes within the record drawings that indicate snow loads beyond the 40 psf uniform roof snow load were considered. Snow drifts were likely not included in the original analysis as the 1982 UBC did not include specific provisions for snow drift loading. These requirements were not widely recognized as necessary for building safety until later. Under the currently adopted 2021 version of the International Building Code (IBC), the code required uniform roof snow load for Palmer is still 40 psf. However, modern codes also include provisions to account for snow drifts.

PND performed calculations on the existing roof members to evaluate the expected capacity of the members when possible. The record drawings indicate that the low roof joists are Trus Joist TJI 45 series joists spaced at 16" on center. No product data older than 1985 was available for the Trus Joist products. In the absence of this legacy data, approximate calculations were performed the on joists by analyzing the modern-day joists that have the same flange dimensions as the joists observed in the field. The observed TJI 45 joists had 3-1/2" wide flanges which are similar to the modern I90 joists by Boise Cascade. Using this rough approximation, it appears the roof members were likely correctly sized for a uniform roof snow load of 40 psf. The low roof and high roof glu-lam beams were also analyzed, many of the members had very little reserve capacity left available after the application of the building self-weight and uniform snow load. The low roof members were then evaluated with the additional snow drift loading that would be required by the current building code. Current building code requires the application of a tapered snow drift over the 16.5 feet of low roof starting at the step between the high and low roofs along gridline 3. The snow drift adds 59 psf of snow load in addition to the 40 psf uniform snow drift and the tappers to zero over the 16.5 feet. This drift loading was not required in the 1980s when the structure was designed. With the additional snow drift loading, it was found that the 5-1/8" x 18" glu-lam beams supporting the low roof would be at 120% of their bending capacity.
